US Army Corps
of Engineers

OPERATION MAKE SAFE PROJECT UPDATE Oct. 12, 2011

Birds Point - New Madrid Floodway
Missouri

New Madrid Project Office

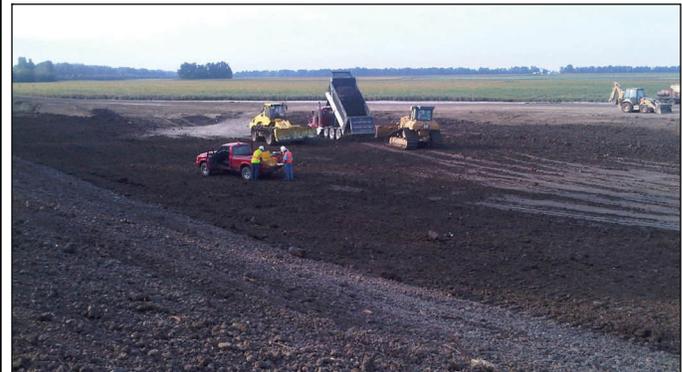
Clay embankment is placed in the final scour hole at the upper crevasse Wednesday to prevent seepage.

Upper crevasse: A Memphis District crew consisting of 22 personnel and 16 pieces of heavy equipment is on site. Crews are currently filling the final of five scour holes, as well as building a bed of clay on the land side of the levee to prevent seepage. A contractor began delivery of clay Tuesday, making a seamless transition between haul service contracts. There is continuous levee now the entire length of the crevasse. A total of 6,800 feet of levee meets or exceeds a (Cairo) gage elevation of 51 feet at this location. No point of the remaining 2,200 feet is less than three feet below the interim grade, and most of the levee is within one foot. Low spots will be raised in the next week to bring the levee fully up to the interim grade.

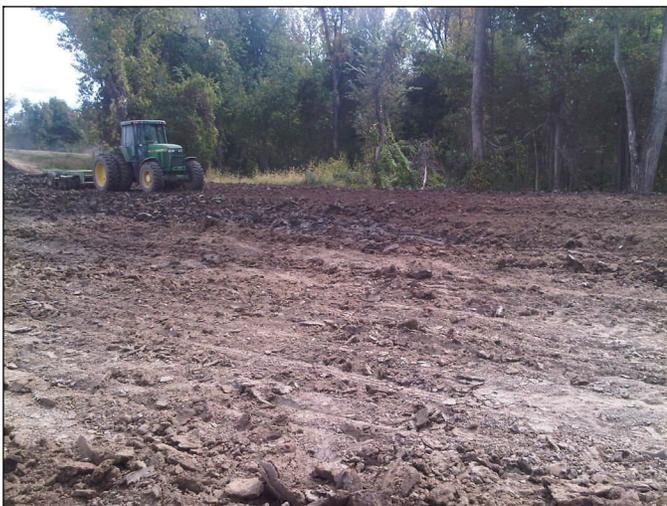
A Vicksburg-based operator prepares a 300-foot-long washout for repair near the lower crevasse Wednesday.

Lower crevasse: A Vicksburg District crew consisting of 14 personnel and 16 pieces of heavy equipment is on site. The crew completed the final 1,200 foot levee segment Monday. The crew is currently dressing and finish-grading the levee, as well as repairing two washed-out segments that were not part of the original scope of work.

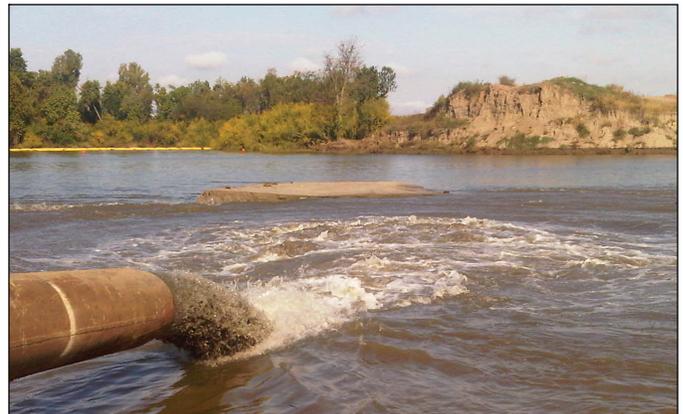
Sand dredged from the Mississippi River is pumped into the scour hole at the center crevasse Wednesday.

Center crevasse: A Memphis District crew consisting of seven personnel and ten pieces of heavy equipment is on site. The crew continued harvesting sand for use as fill material in the scour hole. The dredge contractor began pumping sand from the Mississippi River into the scour hole Saturday. Dredging is scheduled to be complete within 30 days.

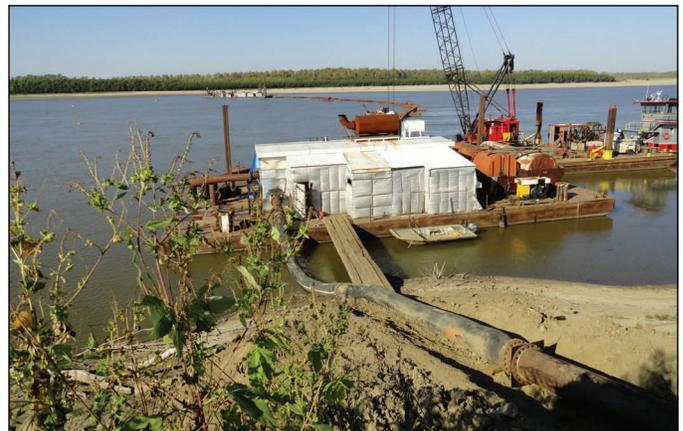
The dredge (background) pumps sand to a booster pump (on barge, center), to the shore pipeline (foreground), and then to the scour hole at the center crevasse.
