# OPERATION MAKE SAFE PROJECT UPDATE

Oct. 24, 2011

Birds Point - New Madrid Floodway  
Missouri

Memphis District

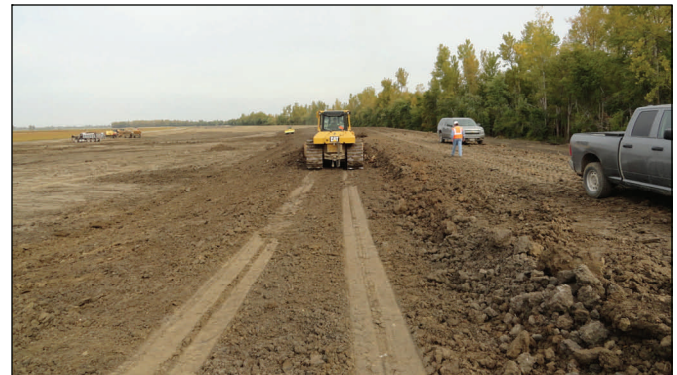
**Clay embankment is placed landside of the levee at the upper crevasse Sunday to prevent seepage.**

**Upper crevasse:** A Memphis District crew consisting of 22 personnel and 16 pieces of heavy equipment is on site here, at a nearby borrow site, and at a maintenance facility. Crews are restoring the bed of clay on the land side of the levee to prevent seepage. A total of 6,800 feet of levee meets or exceeds a (Cairo) gage elevation of 51 feet at this location. Low reaches have been raised and await inspection.

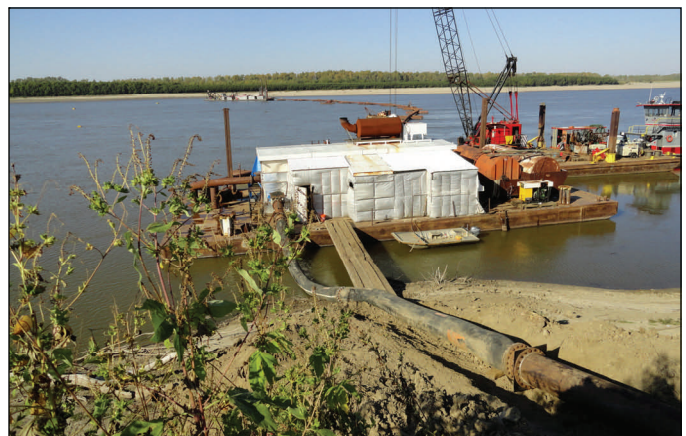
**The dredge (background) pumps sand to a booster pump (on barge, center), to the shore pipeline via a section of flexible pipe (foreground), and then to the scour hole at the center crevasse.**

**Center crevasse:** A Memphis District crew consisting of seven personnel and ten pieces of heavy equipment is on site here and at a nearby borrow site. The crew has ceased harvesting sand from the surrounding fields and is now preparing to extract clay from a borrow site near Ten Mile Pond Conservation Area. The dredge Iowa began pumping sand from the Mississippi River into the scour hole Oct. 8. Pumping will last up to 30 days. The dredge has pumped 235,000 cubic yards of sand into the scour hole to date and averaged more than 20,000 cubic yards per day since Friday.
