# OPERATION MAKE SAFE PROJECT UPDATE Oct. 31, 2011

## Birds Point - New Madrid Floodway Missouri

**New Madrid Project Office**

**Memphis District**

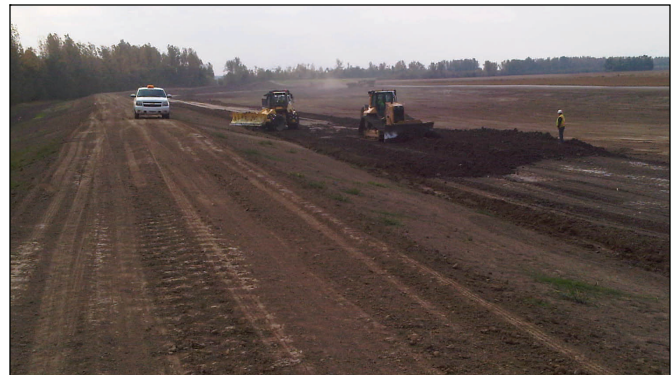
**A bulldozer operator spreads clay landside of the levee at the upper crevasse Oct. 26.**

**Upper crevasse:** A Corps of Engineers crew consisting of 29 personnel and 24 pieces of heavy equipment is on site here, at two nearby borrow sites, and at a maintenance facility. Survey results indicate that the entire 9,000 feet of levee is at or above a (Cairo) gage elevation of 51 feet. Crews continue restoring the bed of clay on the land side of the levee in order to prevent seepage. The District, with assistance from Levee District No. 3 of Mississippi County, Missouri, acquired additional borrow material at Birds Point. The close proximity of the clay will speed repairs and lower transport costs to raise the levee to an elevation of 55 feet on the Cairo gage.

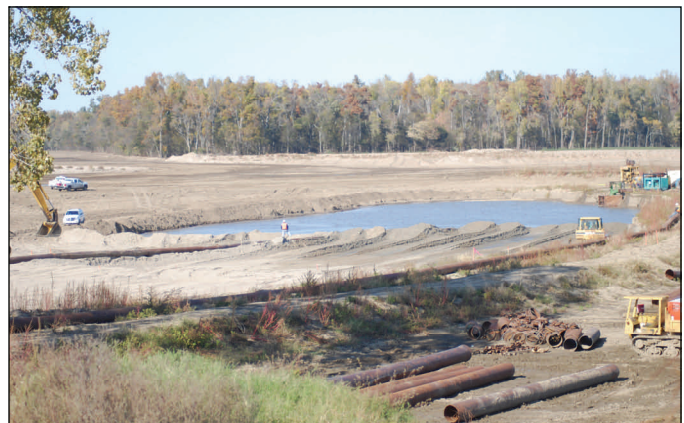
**The dredge Iowa pumps sand into the scour hole at the center crevasse Sunday. Dredging ended Monday.**

**Center crevasse:** A Corps of Engineers crew consisting of 14 personnel and 18 pieces of heavy equipment is on site here and at a nearby clay borrow site. The crew resumed placing clay over the dredged sand Sunday to prevent seepage and serve as the foundation for the repaired levee segment. The scour hole is filled with sand and dredging ended Monday at 8:30 a.m. The dredge Iowa pumped more than 300,000 cubic yards of sand into the scour hole in 24 days of dredging. Next, the crew will cap the sand with clay and reconstruct the levee.

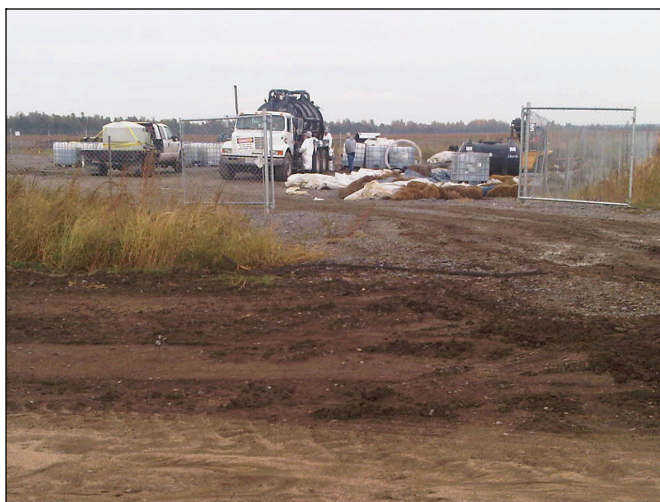
**A contractor at the upper crevasse transfers desensitized blasting agent into USDOT-authorized shipping containers (at left) Oct. 28.**

**Blasting agent removal:** Desensitized blasting agent remains stored at the upper and lower crevasses. The results of a laboratory characterization confirmed the blasting agent is not an explosive risk. The blasting agent has all been transferred into shipping containers. A contractor is making final preparations for shipping before removing the material to a disposal site in central Illinois.

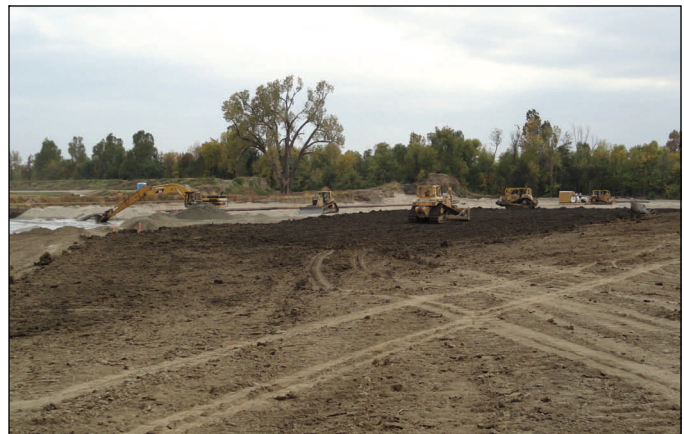
**Clay is spread at the center crevasse Oct. 27 to cover the dredge sand that was placed in the scour hole. This clay will form the foundation of the levee and serve as a landside seepage barrier.**
