# OPERATION MAKE SAFE PROJECT UPDATE

Oct. 5, 2011

Birds Point - New Madrid Floodway  
Missouri

Memphis District

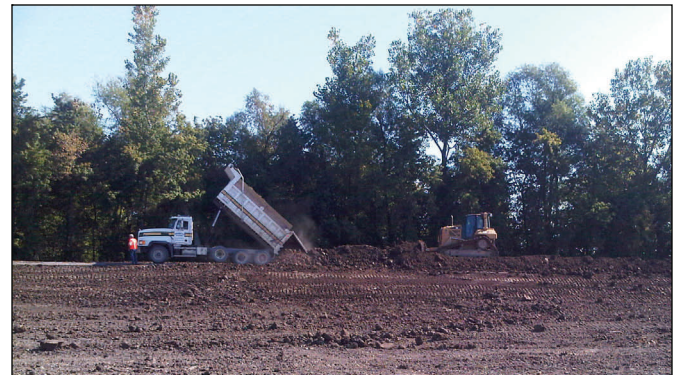
**Clay embankment is dumped and placed in the levee at the upper crevasse Wednesday.**

**Upper crevasse:** A Memphis District crew consisting of 22 personnel and 16 pieces of heavy equipment is on site. Crews are currently filling the final of five scour holes, as well as reconstructing the levee over the top of the previously-filled scour holes. **A solicitation for haul services was posted Wednesday to transport additional clay embankment (see below for link). Responses are due 2 p.m. Friday.** Nearly 7,000 feet of levee is awaiting inspection. A total of 1,800 feet of levee have been built to a (Cairo) gage elevation of 51 feet at this location.

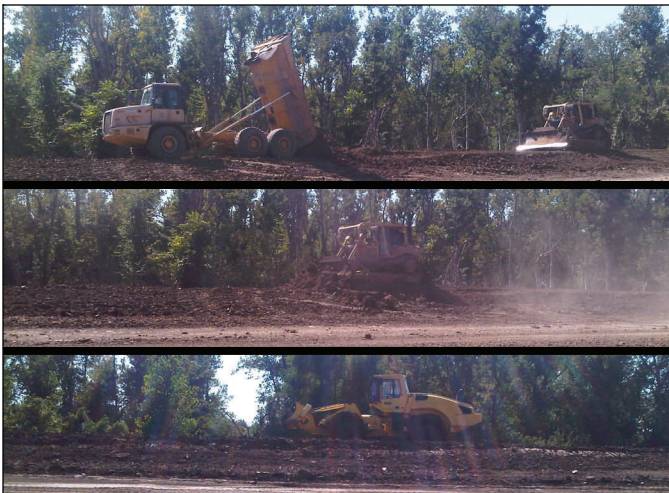
**Constructing levee at the lower crevasse.** Clay is first dumped (top), then spread to a depth of one foot or less (middle), and finally compacted (bottom). The process is repeated until the levee is at the proper elevation.

**Lower crevasse:** A Vicksburg District crew consisting of 14 personnel and 16 pieces of heavy equipment is on site. The crew has completed an additional 1,500-foot long levee segment and has begun reconstruction of the remaining 1,200 feet of levee at this site.

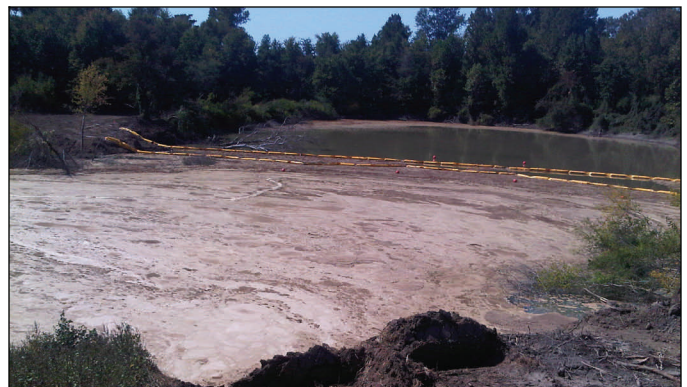
**Engineers installed a silt curtain at the center crevasse this week. The silt curtain will prevent silt plumes from entering the existing scour hole (visible in background).**

**Center crevasse:** A Memphis District crew consisting of seven personnel and ten pieces of heavy equipment is on site. The crew continued harvesting sand for use as fill material in the scour hole. Memphis District engineers have installed a silt curtain to prevent silt plumes from entering the existing scour hole. The dredge contractor is currently constructing a pipeline that will be used to pump sand from the Mississippi River to the scour hole. The dredge arrived Friday and dredging is scheduled to begin in early October.

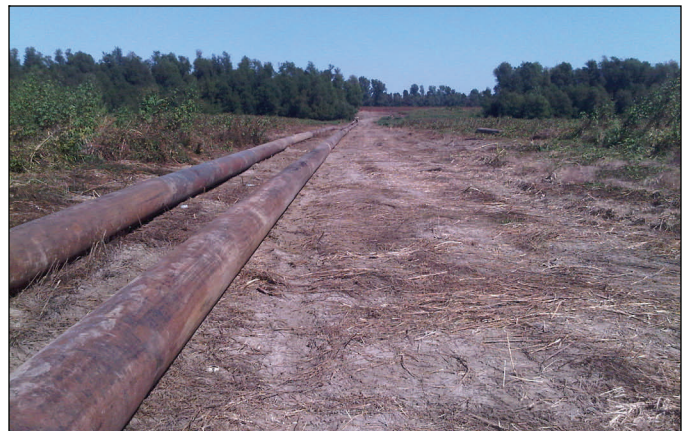
**The dredge contractor is constructing a pipeline that will transport sand from the dredge to fill the scour hole at this location. As of Wednesday, approximately 80 percent of the required pipe had been installed.**
