OPERATION MAKE SAFE PROJECT UPDATE Sept. 26, 2011

Birds Point - New Madrid Floodway Missouri

New Madrid Project Office

Memphis District

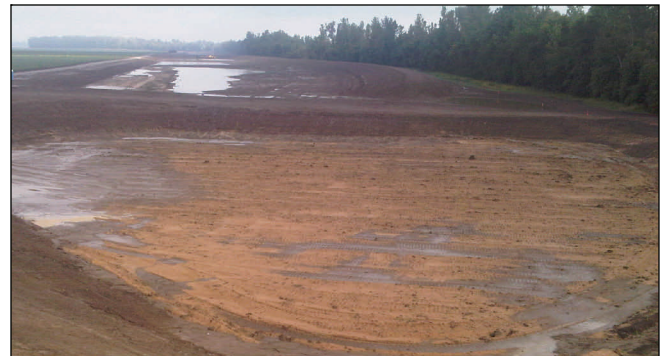
Monday morning was wet and muddy at the upper crevasse. Afternoon sun helped to dry the ground, but not yet enough to support heavy equipment.

Upper crevasse: A Memphis District crew consisting of 22 personnel and 16 pieces of heavy equipment is on site. All five scour holes are filled with sand to the required depth. Rain stopped earthwork over the weekend, but will resume Tuesday, weather permitting. Nearly 4,000 feet of levee is awaiting inspection. A total of 1,800 feet of levee have been built to a (Cairo) gage elevation of 51 feet at this location.

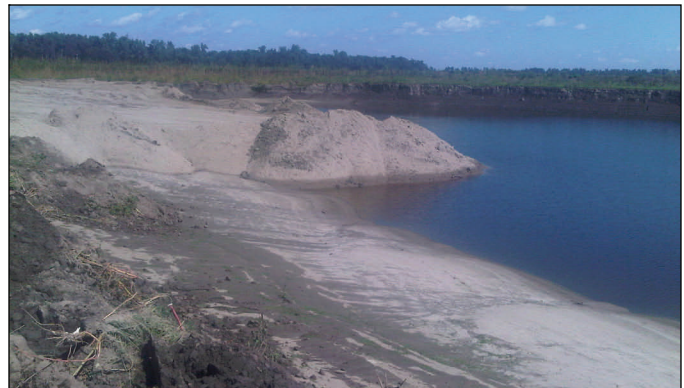
Sand begins to fill the scour hole at the center crevasse Monday. The sand was harvested from the surrounding fields and hauled to the scour hole.

Center crevasse: A Memphis District crew consisting of seven personnel and nine pieces of heavy equipment is preparing the ground for construction at this site. The crew continued harvesting sand for use as fill material. The dredge contractor is mobilizing shore assets and the dredge itself is expected to arrive by Wednesday.

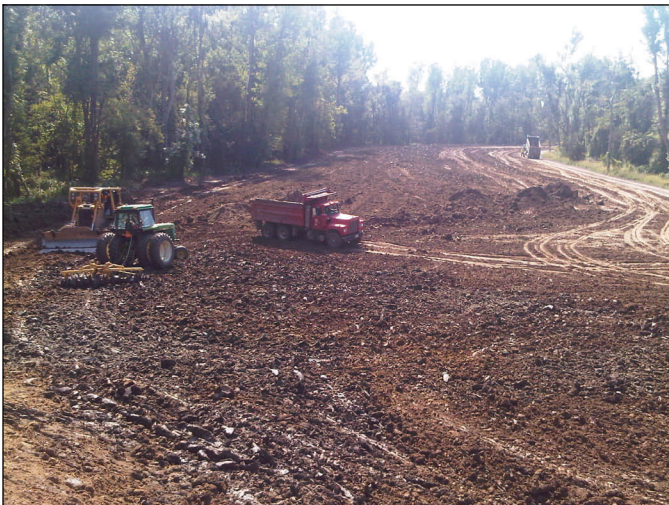
A Vicksburg crew processes material Sept. 21 at the lower crevasse to remove excess water. The soil here is poorly drained and extra effort is required to reduce the moisture content to a workable level. The crew will resume processing material Tuesday.

Lower crevasse: A Vicksburg District crew consisting of 14 personnel and 16 pieces of heavy equipment is on site. A 2,000-foot levee segment is ready for inspection. The crew will resume disking and drying material Tuesday, as well as constructing a 1,500-foot long levee segment.

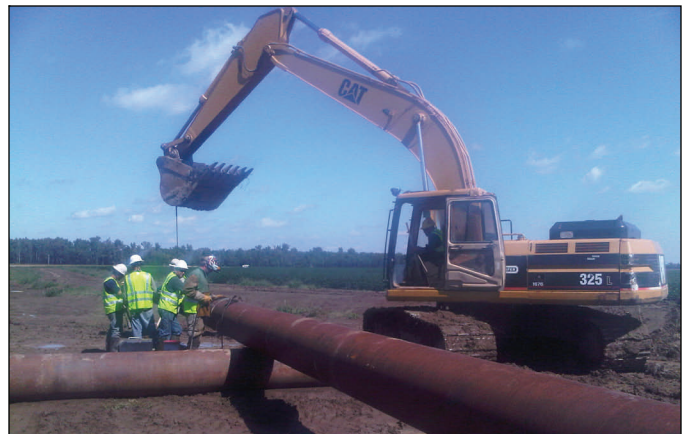
A welder for the dredge contractor joins pipe Monday at the center crevasse. When fully assembled, the pipeline will transport river sand more than a mile to fill the scour hole.

The center crevasse is located near Seven Island Conservation Area. Repairs are required for 800 feet of levee at this location. A scour hole developed here, connecting with the existing 1937 scour hole. Work here includes separating the two scour holes, filling the new scour hole using sand dredged from the river bottom, and repairing the levee to the interim grade.
