# OPERATION MAKE SAFE PROJECT UPDATE

Sept. 28, 2011

## Birds Point - New Madrid Floodway Missouri

### Memphis District

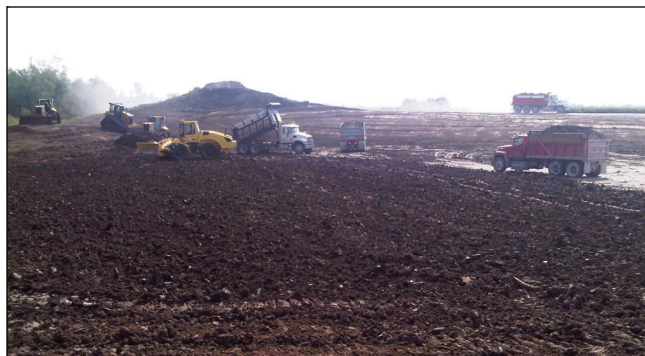
**Work resumed this morning at the upper crevasse. Crews are now filling the last of five scour holes at this location with clay.**

**Upper crevasse:** A Memphis District crew consisting of 22 personnel and 16 pieces of heavy equipment is on site. All five scour holes are filled with sand to the required depth. Crews are currently filling the final of five scour holes. Nearly 4,000 feet of levee is awaiting inspection. A total of 1,800 feet of levee have been built to a (Cairo) gage elevation of 51 feet at this location.

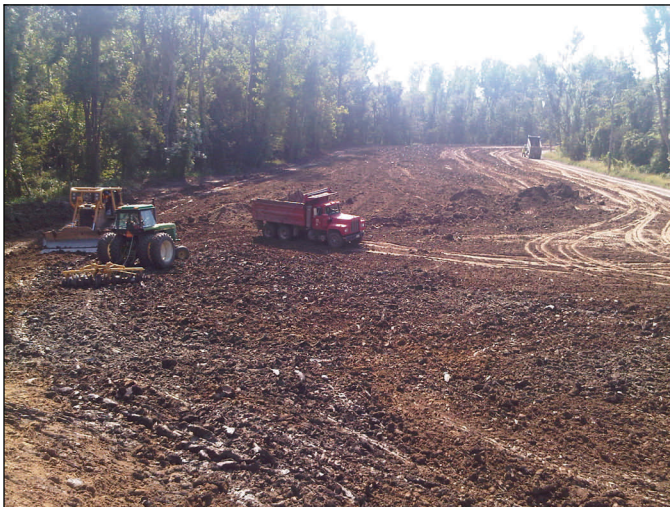
**A Vicksburg crew processes material Sept. 21 at the lower crevasse to remove excess water. The soil here is poorly drained and extra effort is required to reduce the moisture content to a workable level. The crew resumed processing material Tuesday.**

**Lower crevasse:** A Vicksburg District crew consisting of 14 personnel and 16 pieces of heavy equipment is on site. A 2,000-foot levee segment is ready for inspection. The crew resumed disking and drying material Tuesday, and will resume construction of a 1,500-foot long levee segment when the foundation has dried further.

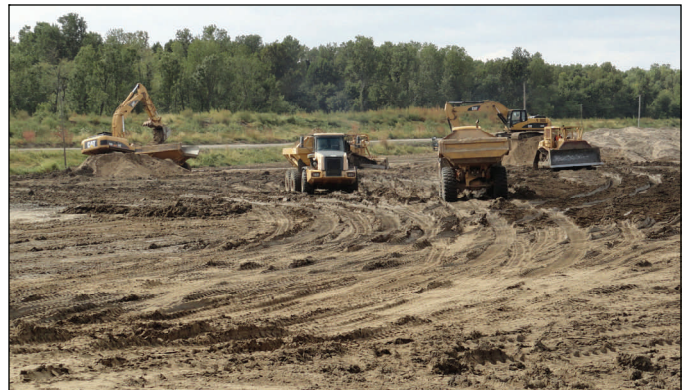
**Loading sand at the center crevasse today. The sand is being used to fill the scour hole at the center crevasse.**

**Center crevasse:** A Memphis District crew consisting of seven personnel and nine pieces of heavy equipment is preparing the ground for construction at this site. The crew continued harvesting sand for use as fill material. The dredge contractor is mobilizing shore assets and the dredge itself is expected to arrive by Wednesday.
