# MAKE SAFE AND RESTORE PROJECT UPDATE Feb. 24, 2012

Birds Point - New Madrid Floodway  
Missouri

Memphis District

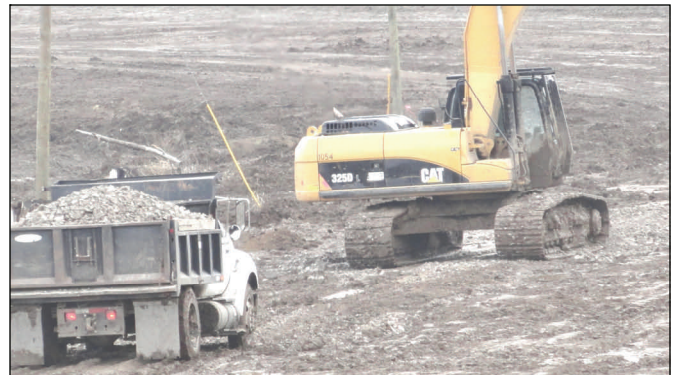
The District's repair team places rock at the center crevasse Feb. 15 to stabilize the roadway.

**An eight-man team arrived Jan. 25 to repair roads at the upper and center crevasses. The team has completed road maintenance at the center crevasse and is relocating to the upper crevasse to repair access roads there.**

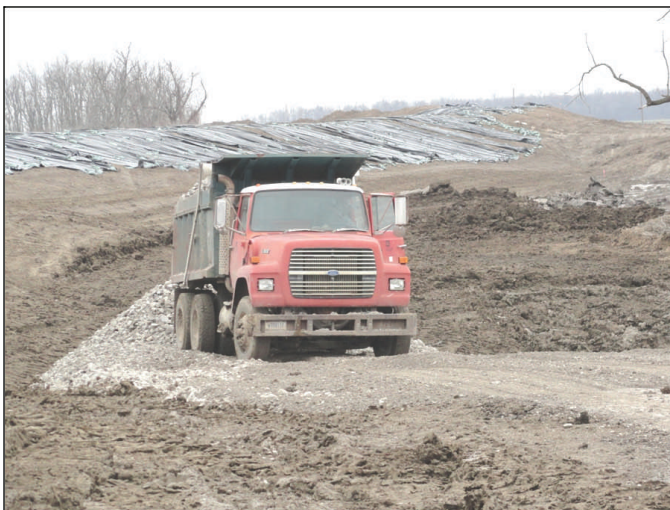
**The team performs road maintenance at the center crevasse Feb. 9. Here, the team places rock to stabilize the eastern access road.**

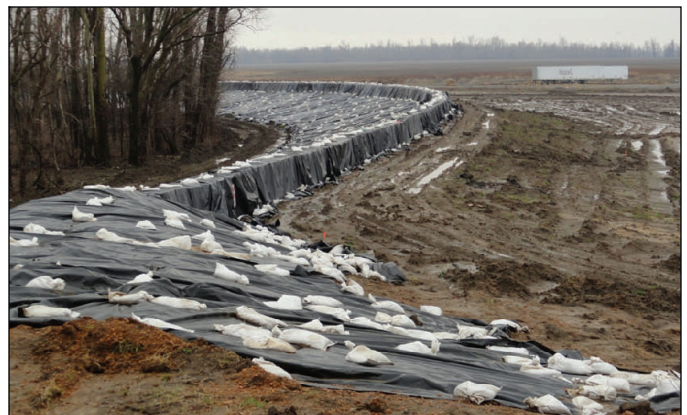
**The repair team completed repairs to the plastic at the upper crevasse Feb. 2. The team also added additional sandbags to better hold the plastic in place.**

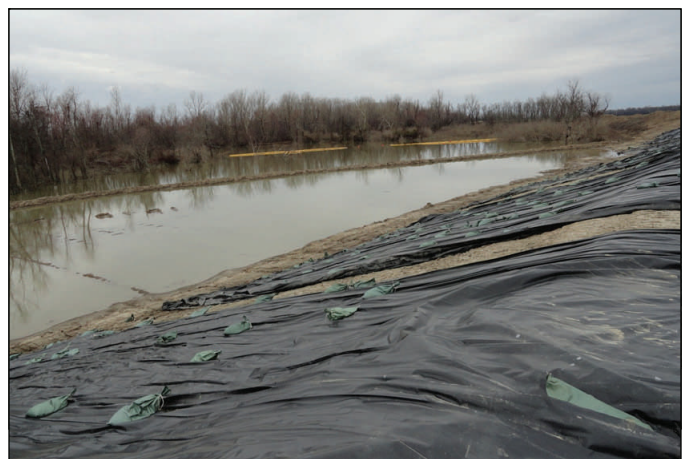
**River water topped out at less than one foot against the levee at the center crevasse Feb. 3 before receding.**
