# MAKE SAFE AND RESTORE PROJECT UPDATE March 16, 2012

**Birds Point - New Madrid Floodway  
Missouri**

**New Madrid Project Office**

**Memphis District**

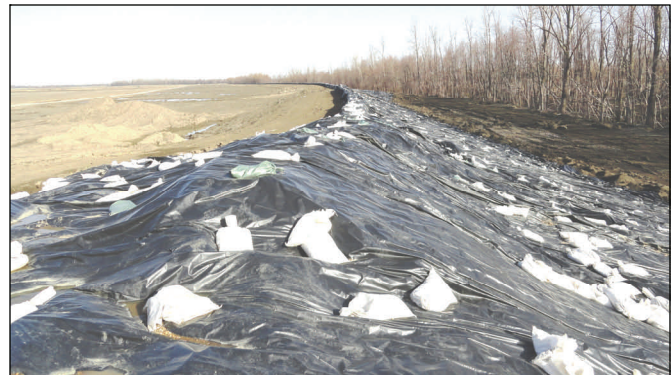
**Plastic sheeting to protect the levee and HESCO barriers is shown in this March 1 view.**

*A small crew is currently in the Floodway to repair wind-damaged plastic. They will return to Memphis when complete with the repairs.*

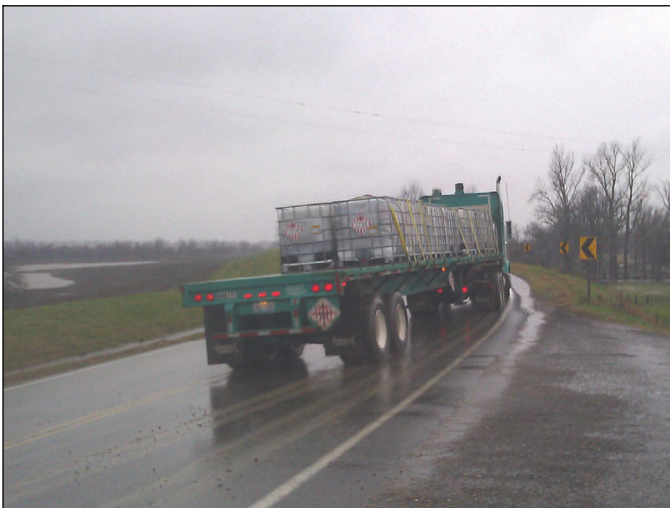
**A tractor-trailer transporting desensitized blasting agent leaves the upper crevasse March 8. All blasting agent has now been removed from the Floodway and has been transferred to a disposal site in Illinois.**

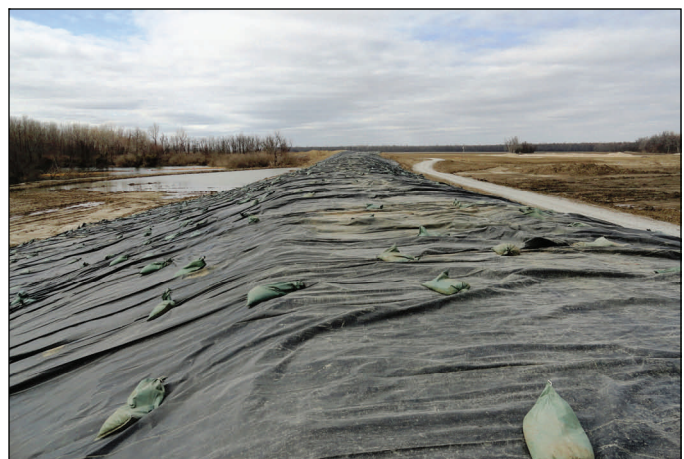
**A March 1 view of the repaired levee at the center crevasse. The access road is visible at right.**

**Center crevasse:** Interim repairs were completed Dec. 3. Remaining earthwork to thicken the landside clay bed to better prevent against seepage, as well as seeding the levee with grass, will be rolled over to Restore.
