MAKE SAFE AND RESTORE PROJECT UPDATE March 9, 2012

**Birds Point - New Madrid Floodway
Missouri**

New Madrid Project Office

Memphis District

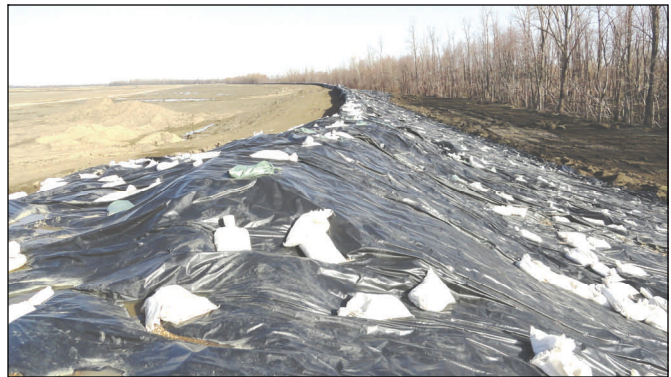
Plastic sheeting to protect the levee and HESCO barriers is shown in this March 1 view.

A small crew is in the Floodway this week to repair plastic damaged during last week's severe weather.

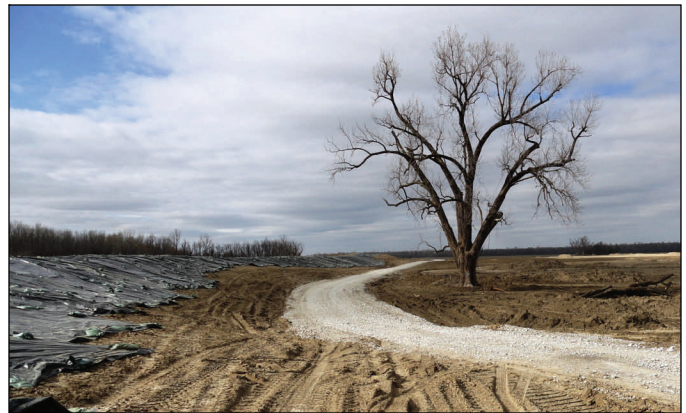
The repair team completed the center crevasse access road in late February. The road provides all-weather access to the levee. March 1 photo.

The project is in maintenance status for the winter. Scheduled maintenance to repair access roads began Jan. 25 and was completed March 2. Operation Restore is now funded. Earthwork to further expand the levee and reconstruct it to the full authorized level of protection will resume when field conditions allow. Plans and specifications are in development. Contracting and construction schedules are under review.

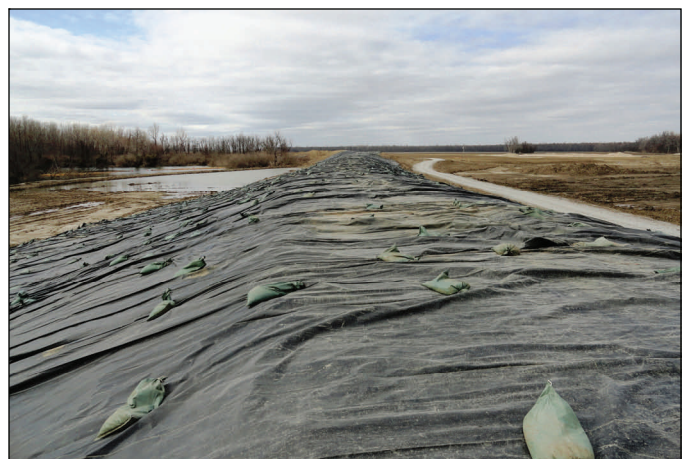
A March 1 view of the repaired levee at the center crevasse. The access road is visible at right.

Center crevasse: Interim repairs were completed Dec. 3. Remaining earthwork to thicken the landside clay bed to better prevent against seepage, as well as seeding the levee with grass, will be rolled over to Restore.
