US Army Corps
of Engineers

MAKE SAFE AND RESTORE PROJECT UPDATE March 2, 2012

Birds Point - New Madrid Floodway Missouri

Memphis District

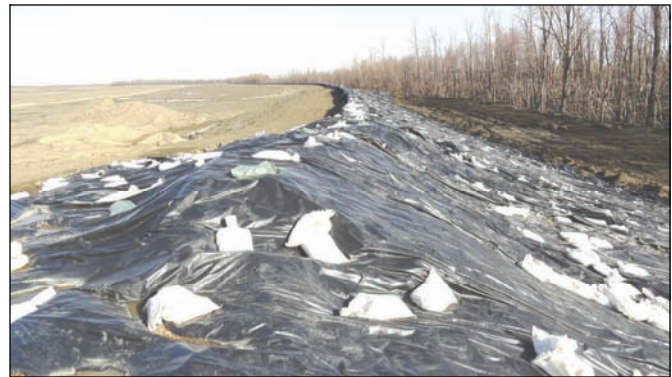
Plastic sheeting to protect the levee and HESCO barriers is shown in this March 1 view.

Upper crevasse: The crew has completed permanent levee repairs to a (Cairo) gage elevation of 51 feet as of Oct. 28, and temporary protection with HESCO barriers to 55 feet as of Dec. 13. Remaining earthwork to complete the restoration of the clay bed on the landside of the levee as well as seeding the levee with grass, will be rolled over to Restore.

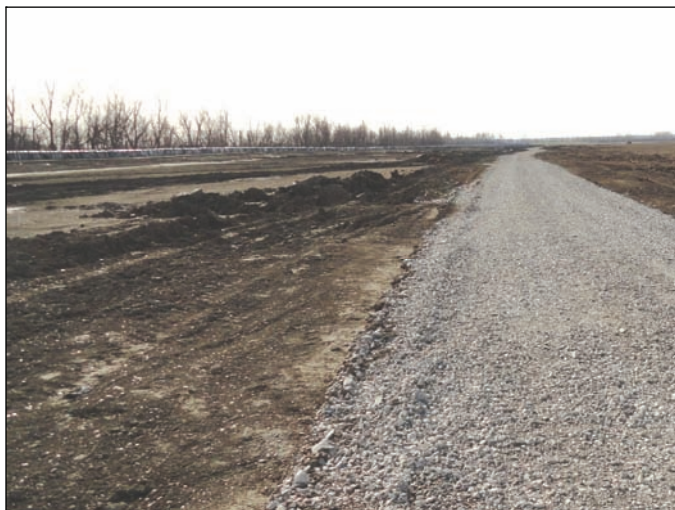
The team completed improvements to the land-side access road at the upper crevasse today. This section, pictured March 1, shows a completed segment. The improved road provides all-weather access to the levee.

An eight-man team arrived Jan. 25 to repair roads at the upper and center crevasses. The team completed scheduled road maintenance and additional work March 2. The team is demobilizing back to Memphis.

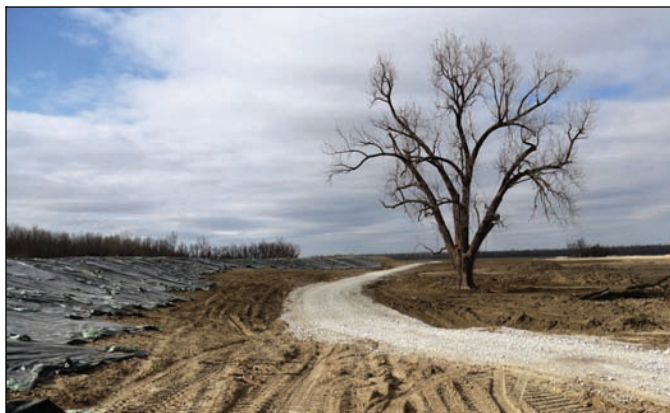
The repair team completed the center crevasse access road in late February. The road provides all-weather access to the levee. March 1 photo.

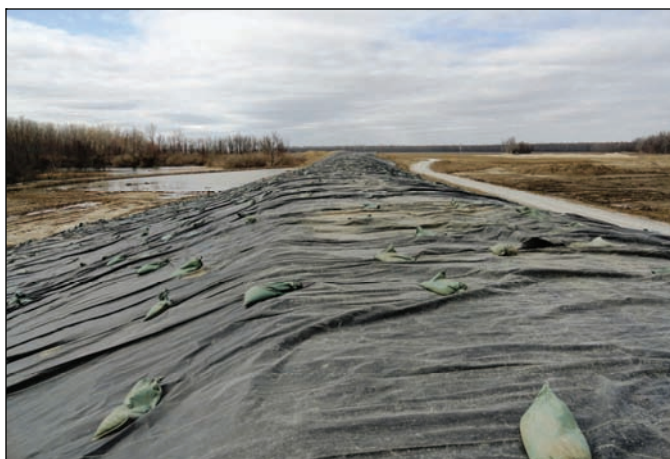
A March 1 view of the repaired levee at the center crevasse. The access road is visible at right.

Center crevasse: Interim repairs were completed Dec. 3. Remaining earthwork to thicken the landside clay bed to better prevent against seepage, as well as seeding the levee with grass, will be rolled over to Restore.
