# OPERATION MAKE SAFE PROJECT UPDATE

Feb. 10, 2012

Birds Point - New Madrid Floodway  
Missouri

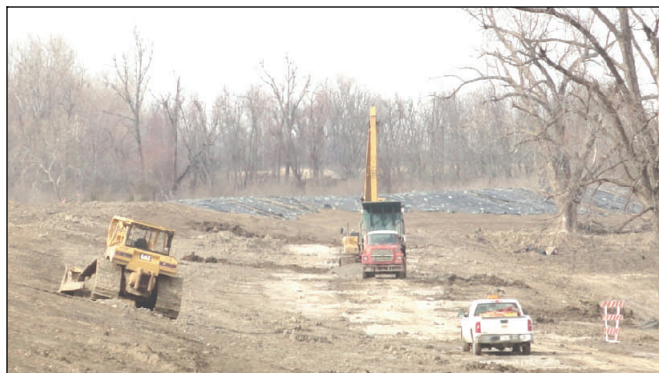
**The District's repair team places rock at the center crevasse Thursday to stabilize the roadway.**

*An eight-man team arrived Jan. 25 to repair roads at the upper and center crevasses. The team is currently performing road maintenance at the center crevasse.*

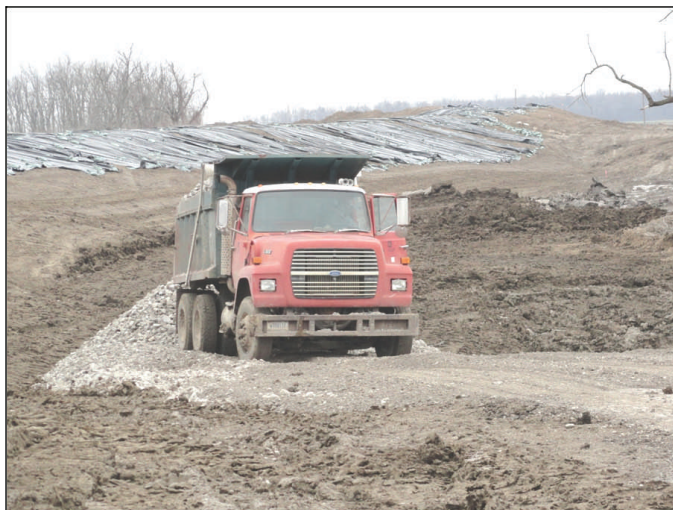
**The team performs road maintenance at the center crevasse Thursday. Here, the team places rock to stabilize the eastern access road.**

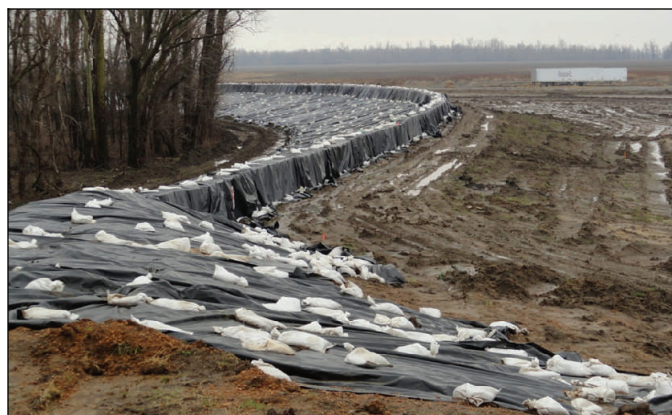
**The repair team completed repairs to the plastic at the upper crevasse Feb. 2. The team also added additional sandbags to better hold the plastic in place.**

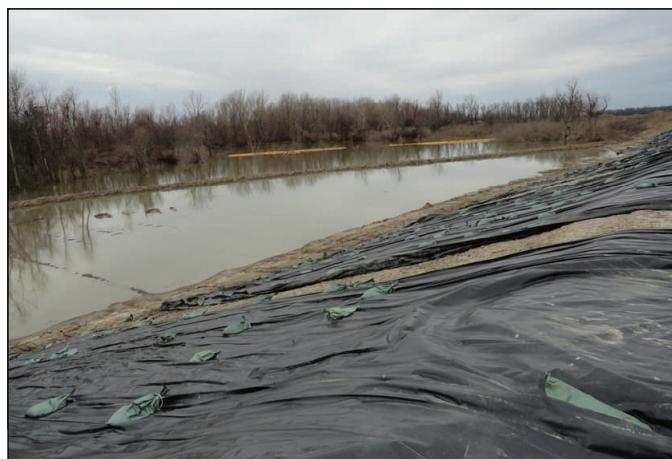
**River water topped out at less than one foot against the levee at the center crevasse Feb. 3 before receding.**
