# OPERATION MAKE SAFE PROJECT UPDATE Feb. 17, 2012

## Birds Point - New Madrid Floodway

### Missouri

#### Memphis District

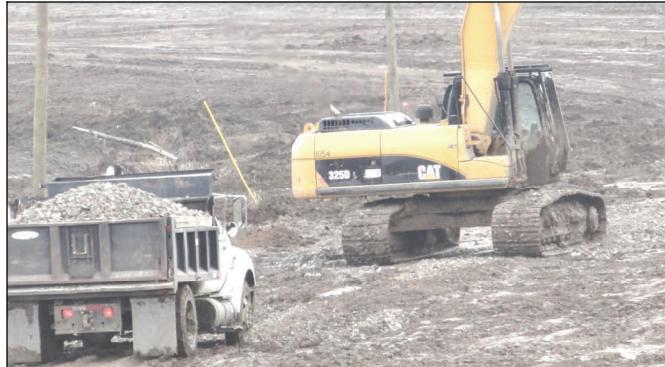
The District's repair team places rock at the center crevasse Wednesday to stabilize the roadway.

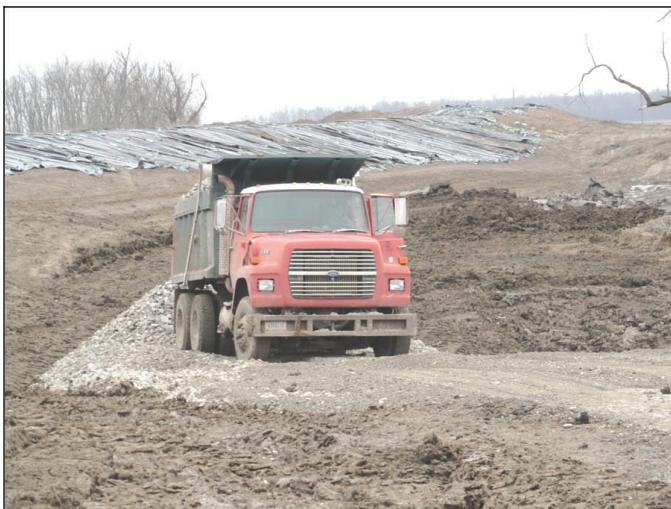
The team performs road maintenance at the center crevasse Feb. 9. Here, the team places rock to stabilize the eastern access road.

An eight-man team arrived Jan. 25 to repair roads at the upper and center crevasses. The team is currently performing road maintenance at the center crevasse.

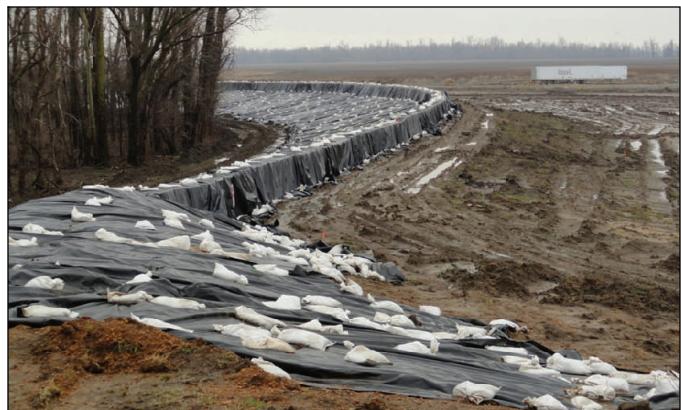
The repair team completed repairs to the plastic at the upper crevasse Feb. 2. The team also added additional sandbags to better hold the plastic in place.

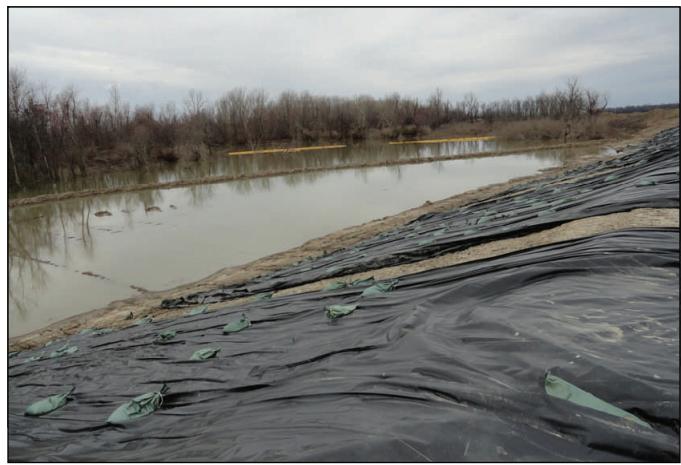
River water topped out at less than one foot against the levee at the center crevasse Feb. 3 before receding.
