US Army Corps
of Engineers

OPERATION MAKE SAFE PROJECT UPDATE Jan. 26, 2012

Birds Point - New Madrid Floodway
Missouri

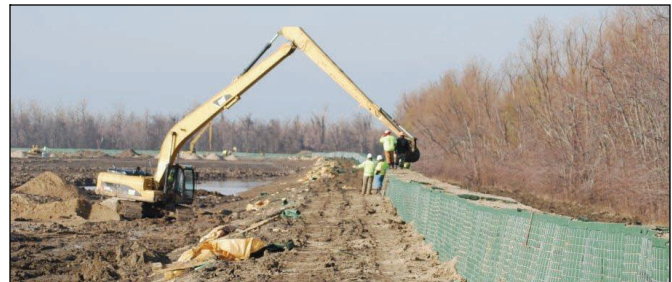
A crew fills HESCO barriers at the upper crevasse Dec. 11. The barriers are a temporary measure to raise the level of protection at Birds Point from 51 to 55 feet on the Cairo gage. Permanent repairs to the levee will resume after spring highwater recedes.

Upper crevasse: The crew has completed permanent levee repairs to a (Cairo) gage elevation of 51 feet as of Oct. 28, and temporary protection with HESCO barriers to 55 feet as of Dec. 13. A small amount of earthwork remains to complete the restoration of the clay bed on the landside of the levee, as well as seeding the levee with grass.

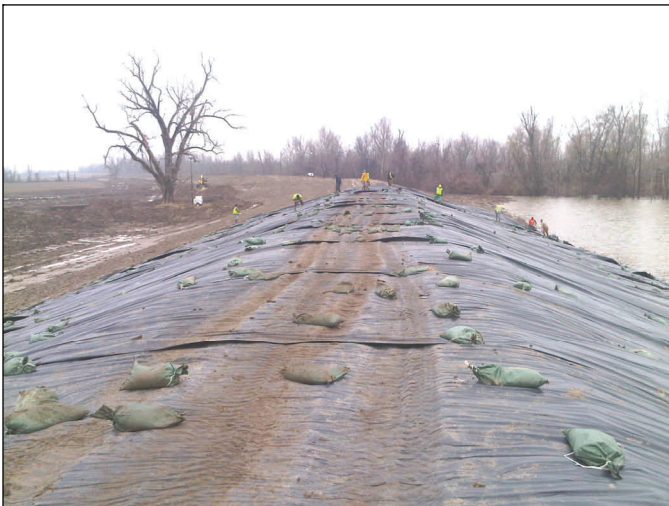
Crews cover the newly-constructed levee segment at the center crevasse with heavy plastic sheeting Dec. 6. The plastic sheeting will help protect the levee against erosion caused by wave action and rainfall. This view looks east along the levee.

Center crevasse: Interim repairs were completed Dec. 3. The 10% of work remaining is thickening the landside clay bed to better prevent against seepage, as well as seeding the levee with grass.

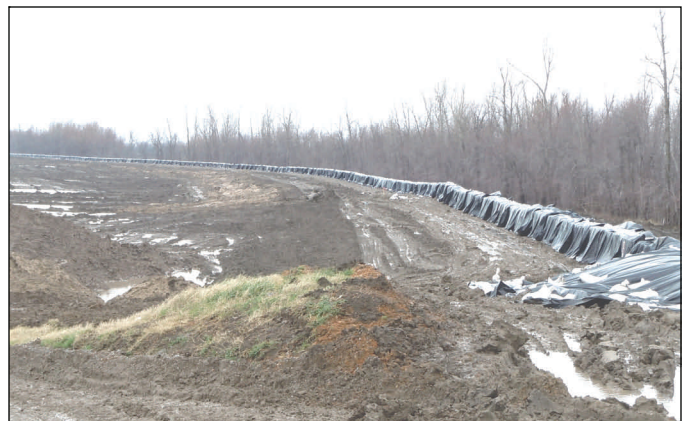
HESCO barriers span the length of the upper crevasse Dec. 15. The plastic sheeting protects against erosion and provides a water-resistant barrier over the HESCOs.
